TECHNICAL REPORT ARLCB-TR-84C41

CHARACTERIZATION OF BORE SURFACE LAYERS IN GUN BARRELS

DECEMBER 1984

US ARMY ARMAMENT RESEARCH AND DEVELOPMENT CENTER
LARGE CALIBER WEAPON SYSTEMS LABORATORY
BENET WEAPONS LABORATORY
WATERVLIET N.J. 12189

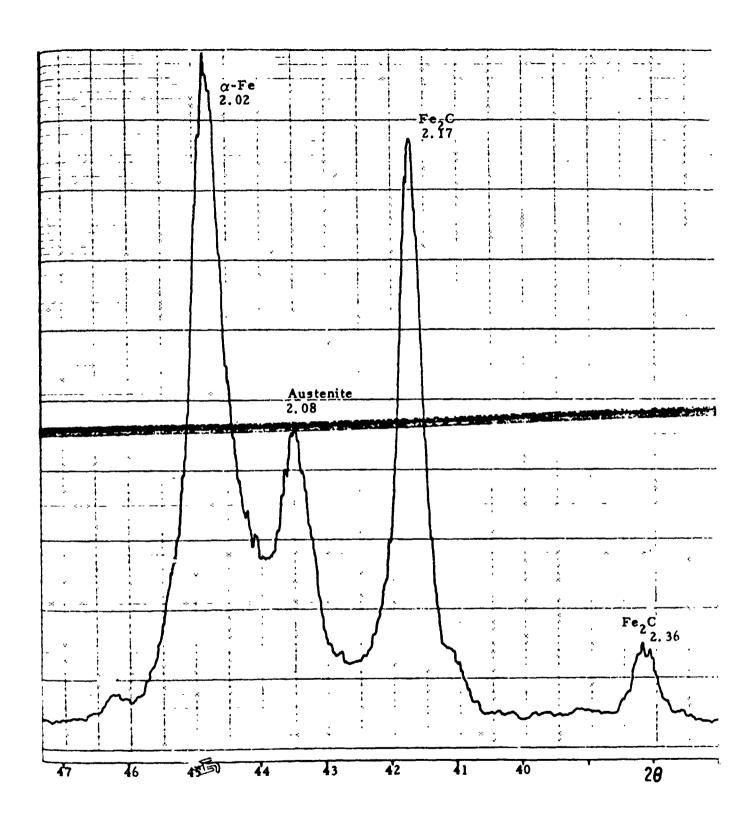
The crystallographic structure of the first white layer was examined by x-ray diffraction. The part of the spectrum showing the major peaks is shown in Figure 8. The data are interpreted as follows:

- 1. The spectrum represents the superposition of diffraction lines from three different materials, Fe₃C, Austenite, and α-Fe.
- 2. The carbon content (~ / wt. percent) of the first white layer determined by means of Auger analysis is consistent with the carbon content of Fe₃C. Austenite or α-Fe are not stable phases in this part of the high carbon, Fe-C phase diagram.
- 3. It follows, therefore, that the first white layer is Fe₃C and that the other diffraction lines must be derived from material lying immediately below the first layer within the penetration depth of the x-ray beam.

Figure 8. X-ray diffraction pattern of first white layer.

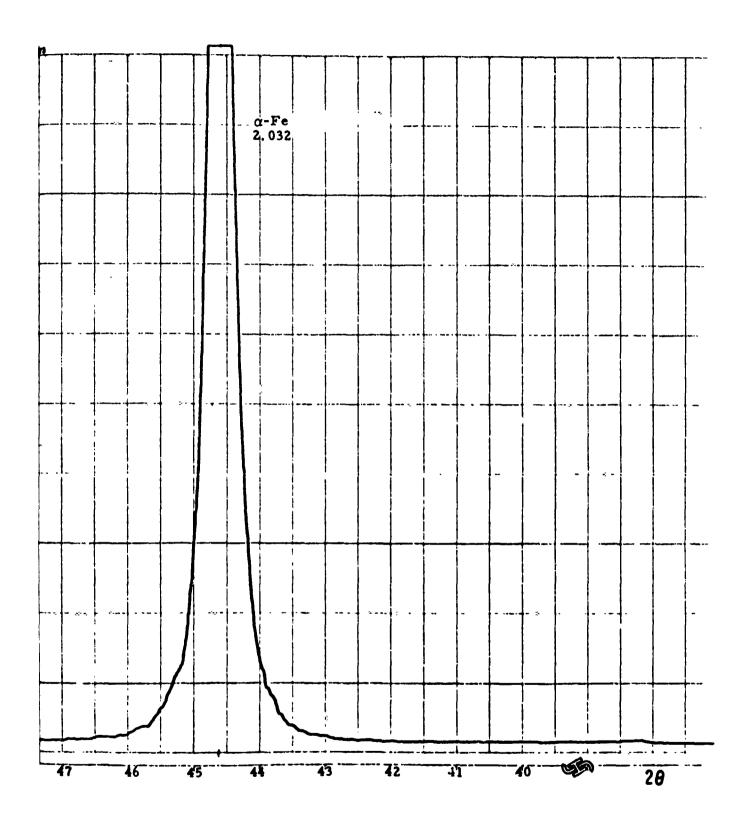
The crystallographic structure of this layer was determined by x-ray diffraction. The specimen from which the first white layer was removed by taper sectioning, thereby exposing sufficiently large areas, was used to obtain diffraction data. The major diffraction peaks observed are shown in Figure 9. For comparison, a diffractogram of the steel matrix covering the same 29 region is shown in Figure 10. The interpretation of these data are as follows:

- 1. A comparison of diffraction patterns in Figures 9 and 10 from the second white layer and the matrix shows that the second white layer is an austenite.

- 3. The precise quantity of austenite in the second white layer could not be established. The relative x-ray peak heights of a-Fe and austenite in Figure 9 could not be used to make such a determination since the intensity of the a-Fe peak almost certainly contains a contribution from the matrix material lying immediately below the second white layer within the penetration depth of the x-ray beam. A quantitative determination was attempted using transmission electron microscopy (TEM), but this approach was not successful. The extensive cracking associated with the bore surface made it impossible to obtain a thin section of the material suitable for examination in the TEM. However, metallographic examination of specimens in Figure 6, indicates that the second white layer is a single phase suggesting that this white layer is composed almost entirely of austenite.

Figure 9. X-ray diffraction pattern of second white layer.
